BEARING LUBRICATION *REIMAGINED*

THE ONLY REAL-TIME BEARING REMOTE FRICTION MONITORING & LUBRICATION SYSTEM. YOU WILL NEVER LOOK AT BEARING LUBRICATION THE SAME AGAIN!

ONTRAK SMARTLUBE OVERVIEW

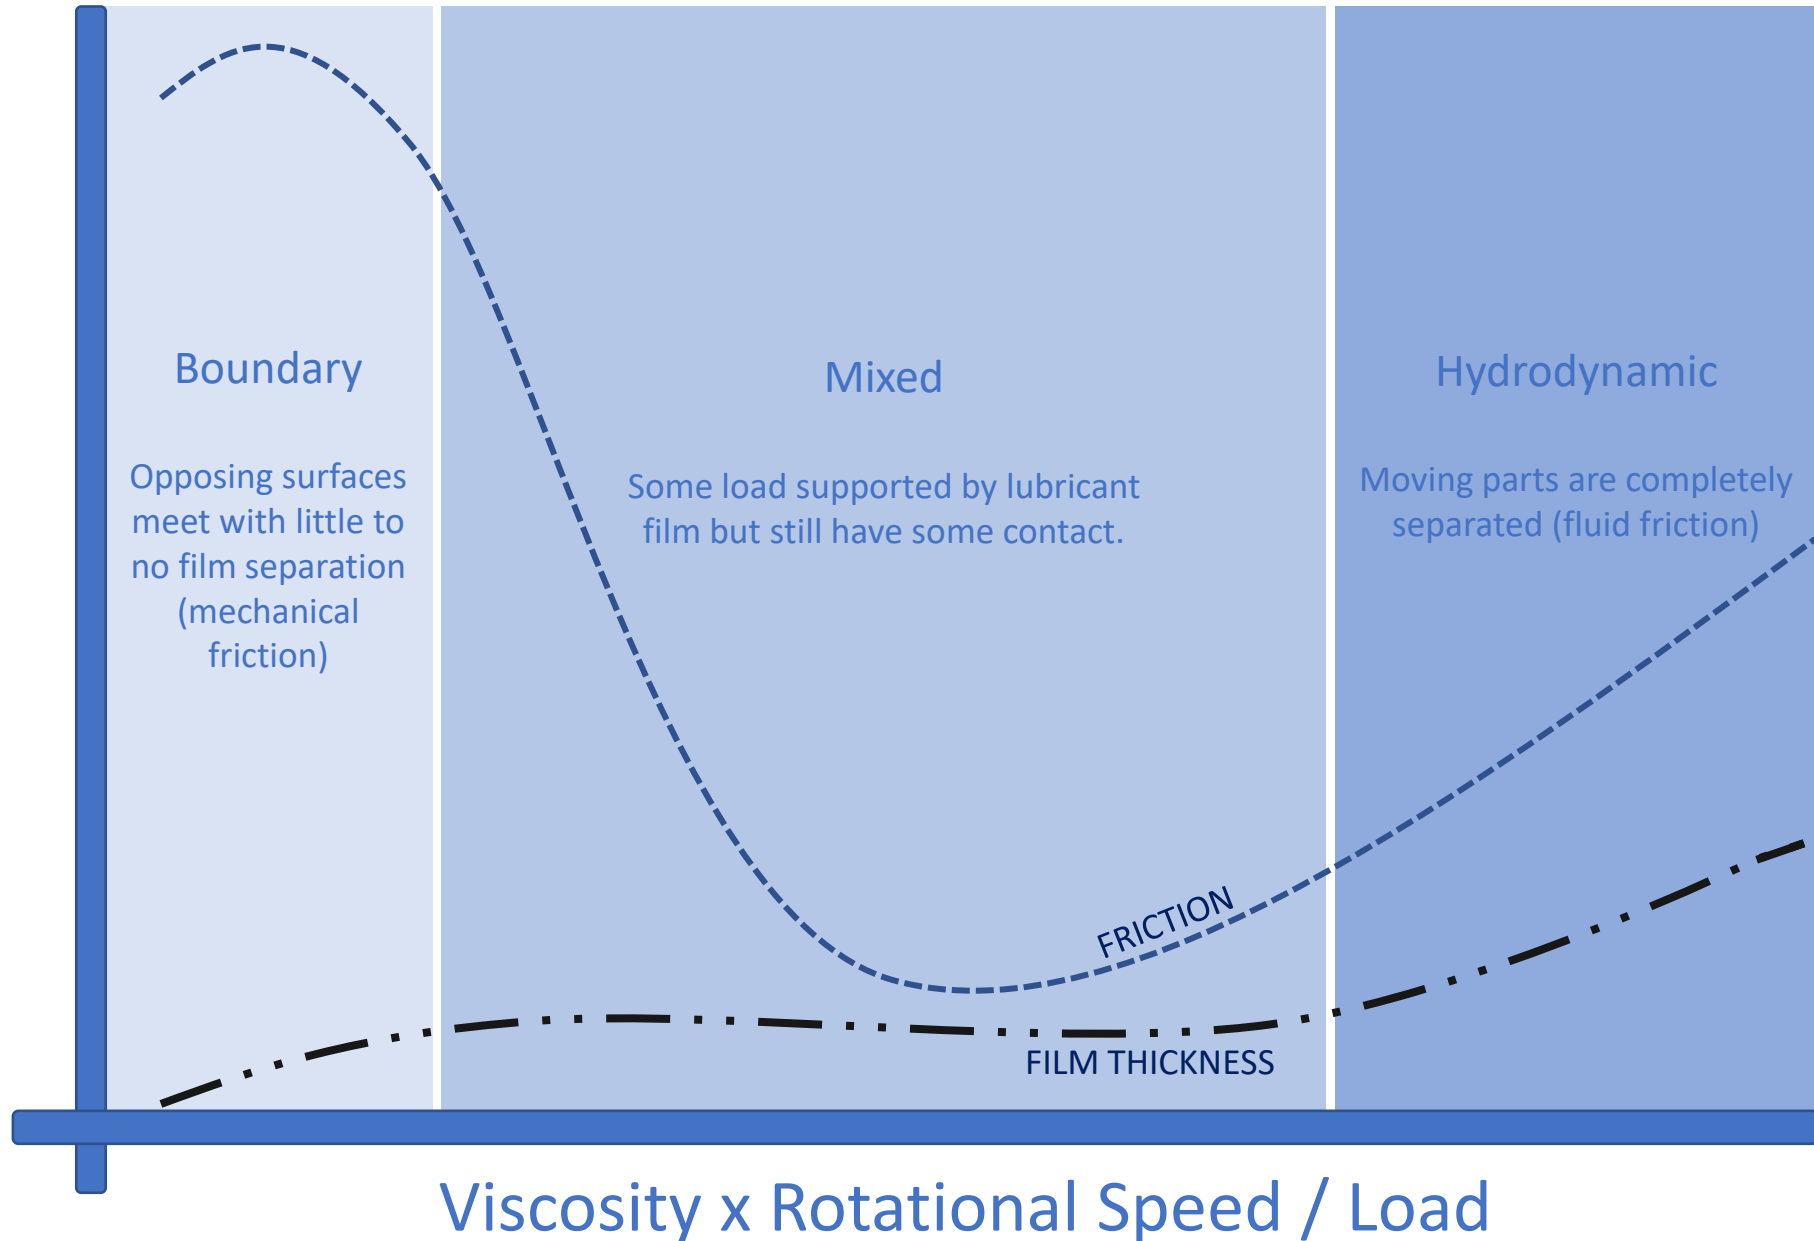
Coefficient of
FRICTION

Viscosity x Rotational Speed / Load

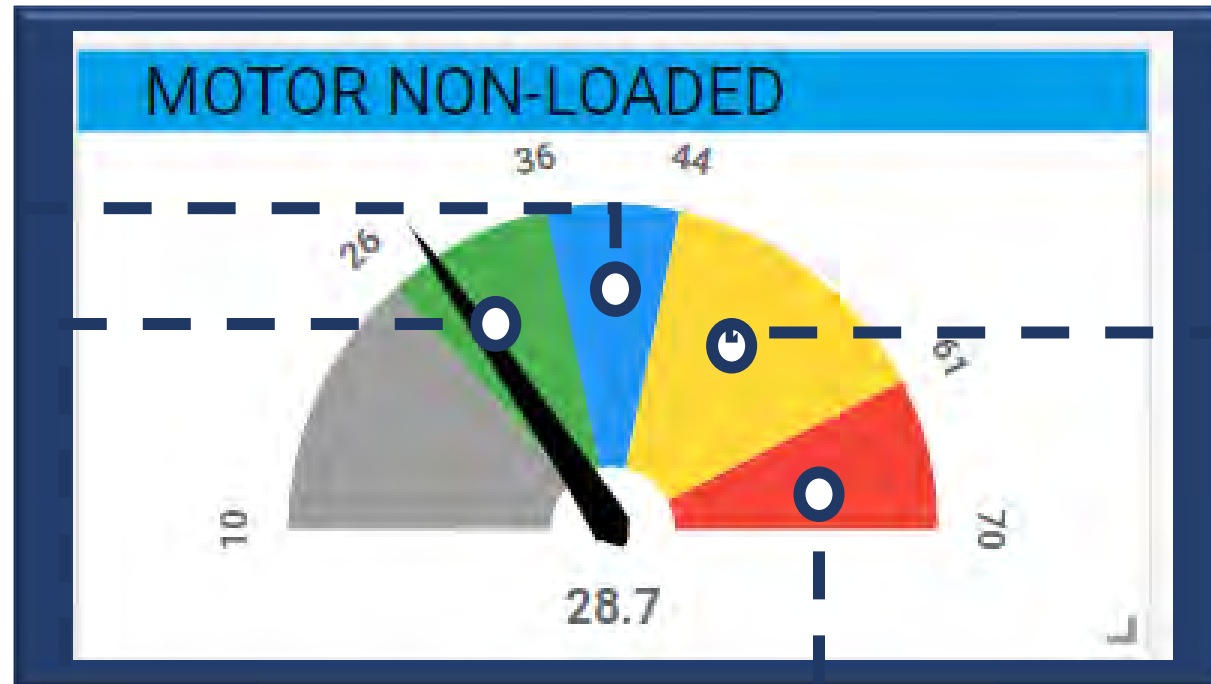
PRESCRIPTIVE

LUBRICATION REQUIRED

8dB above baseline
indicates a **lack of
lubrication.**

BEGINNING OF FAILURE

16dB above baseline
indicates damage to the
bearing – a **failure
mode beyond
lubrication alone.**

HEALTHY BEARING

CLOSE TO FAILURE

35dB above baseline
means the asset is
critical – **it is close
to failure.**

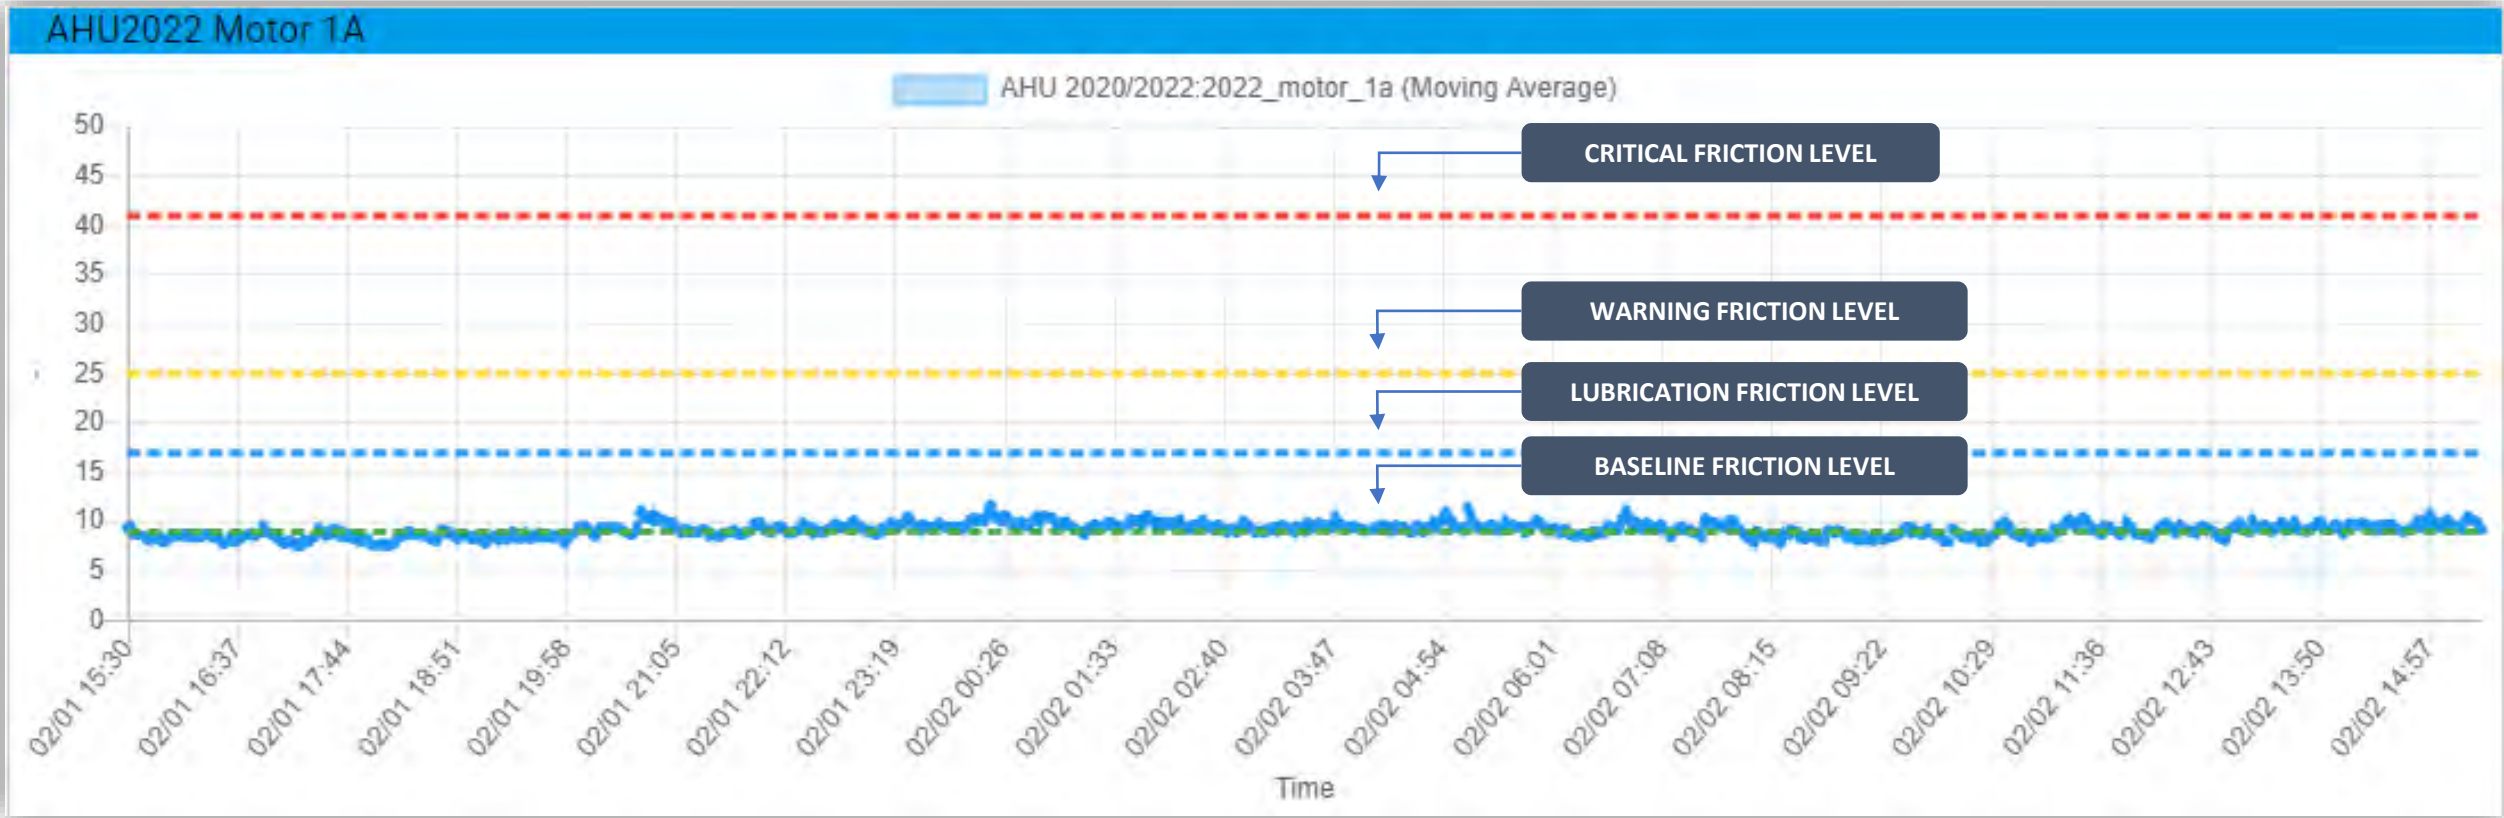
FRICITION TREND IN A HEALTHY BEARING

**DOESN'T THE FRICTION CHANGE
BASED ON VARYING SPEED
CONDITIONS?**

**YES, BUT ONLY A LITTLE.... AND THIS IS WHAT IS
GREAT ABOUT ULTRASOUND AND MONITORING
FRICTION. IN A HEALTHY, PROPERLY LUBRICATED
BEARING THE FRICTION SHOULD NOT CHANGE
DRAMATICALLY. A SLIGHT INCREASE OF 2-3DB MAY BE
SEEN DEPENDING ON THE SPEED CHANGE.**

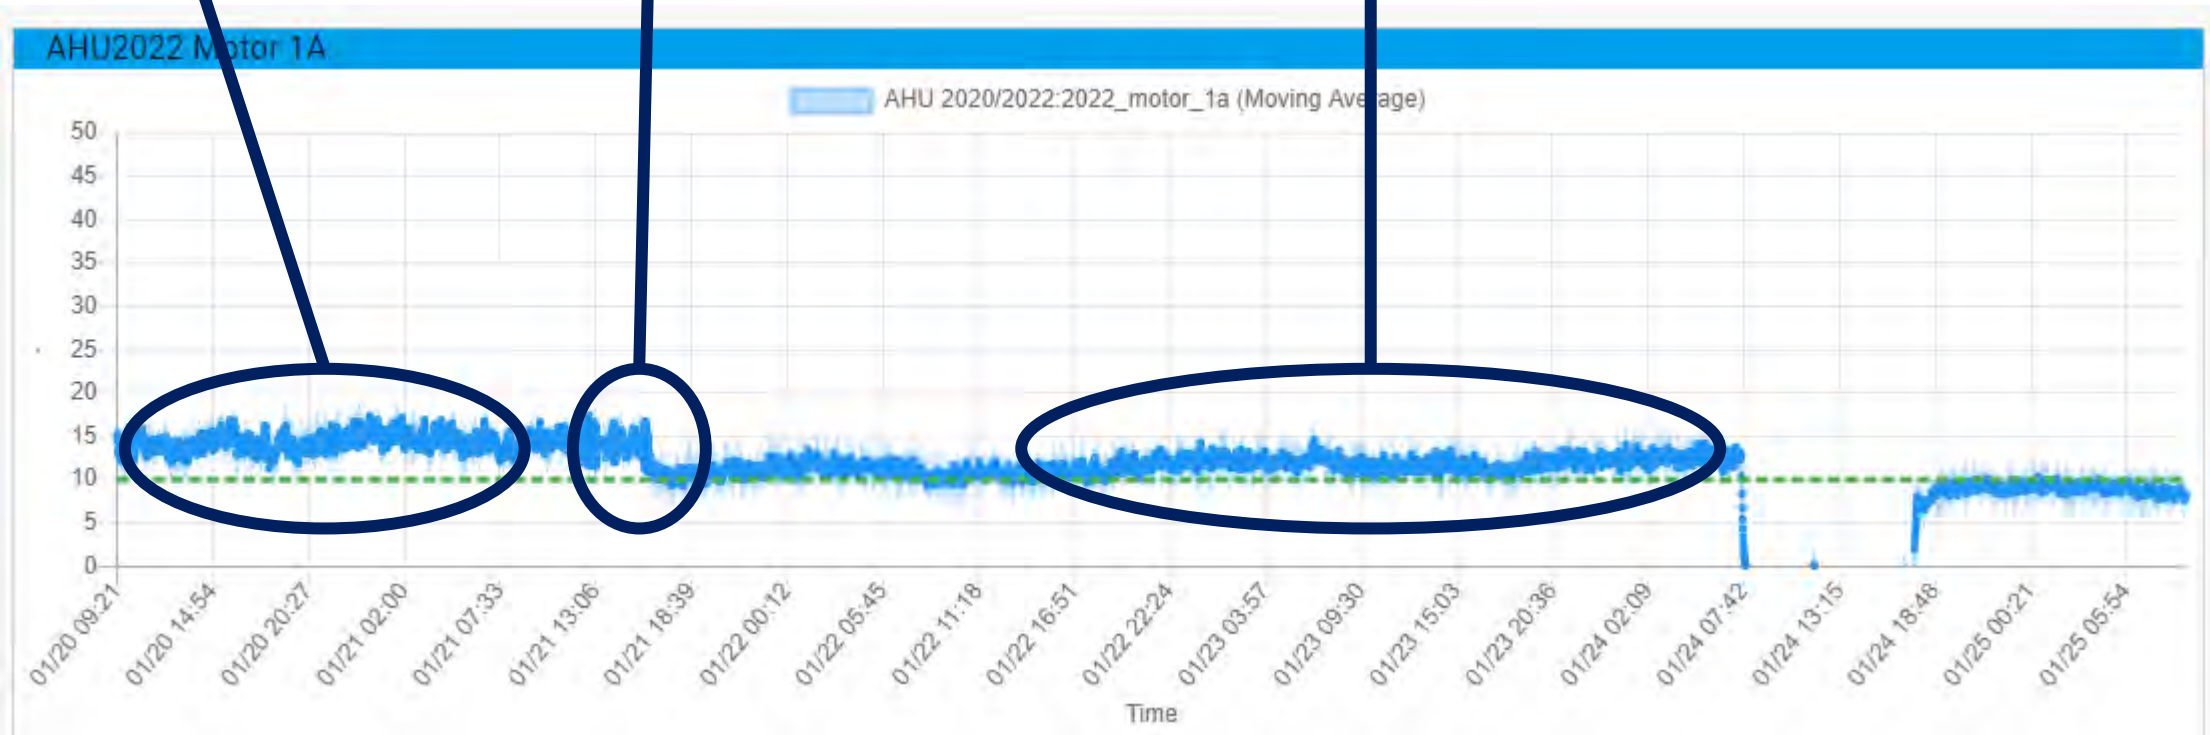
FRICITION TREND IN A UNDER LUBRICATED BEARING

Initial Friction:
Baseline = 14dB
Peak-to-Peak = 6.75db

Lubrication Added:
Amount of Grease = 15cc

Friction After Lubrication
Baseline = 11dB
Peak-to-Peak = 3db

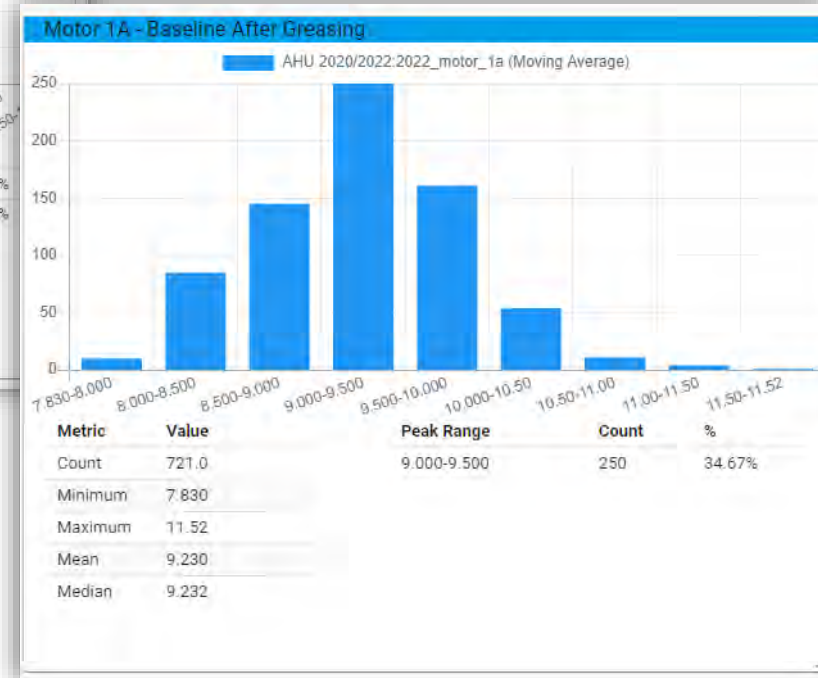
FRICITION TREND IN A UNDER LUBRICATED BEARING

- NOTICEABLE DECREASE IN FRICTION AFTER LUBRICATION
- NOTICEABLE DECREASE IN THE PEAK-TO-PEAK VALUES.
- NOTICEABLE CENTER POINT ON THE HISTOGRAM

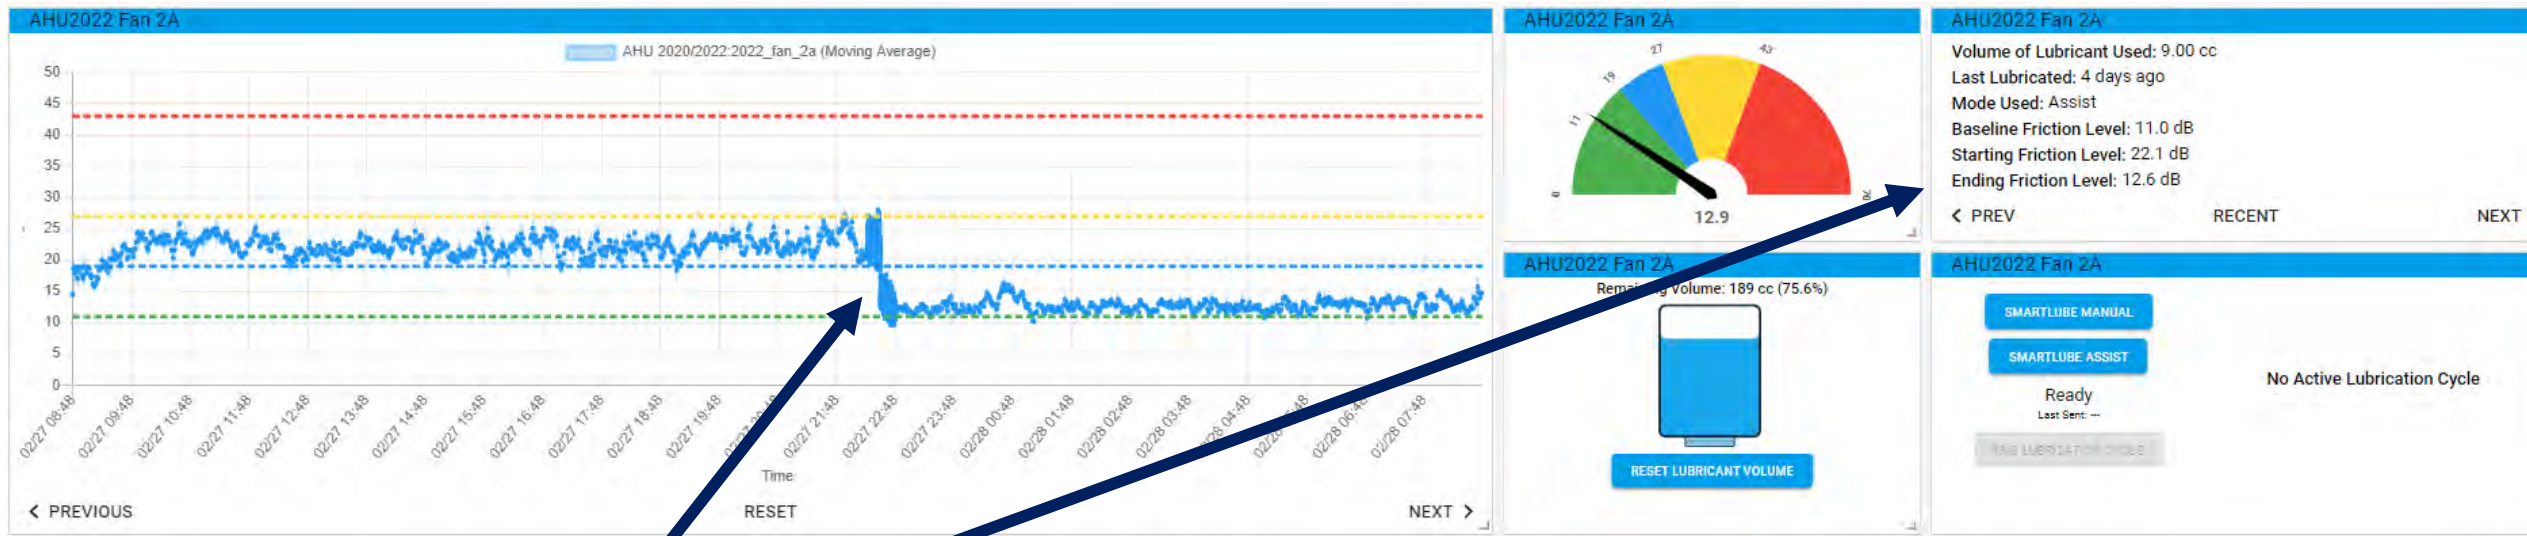
FRICITION TREND IN A UNDER LUBRICATED BEARING

NOTICEABLE DECREASE IN FRICTION AFTER LUBRICATION

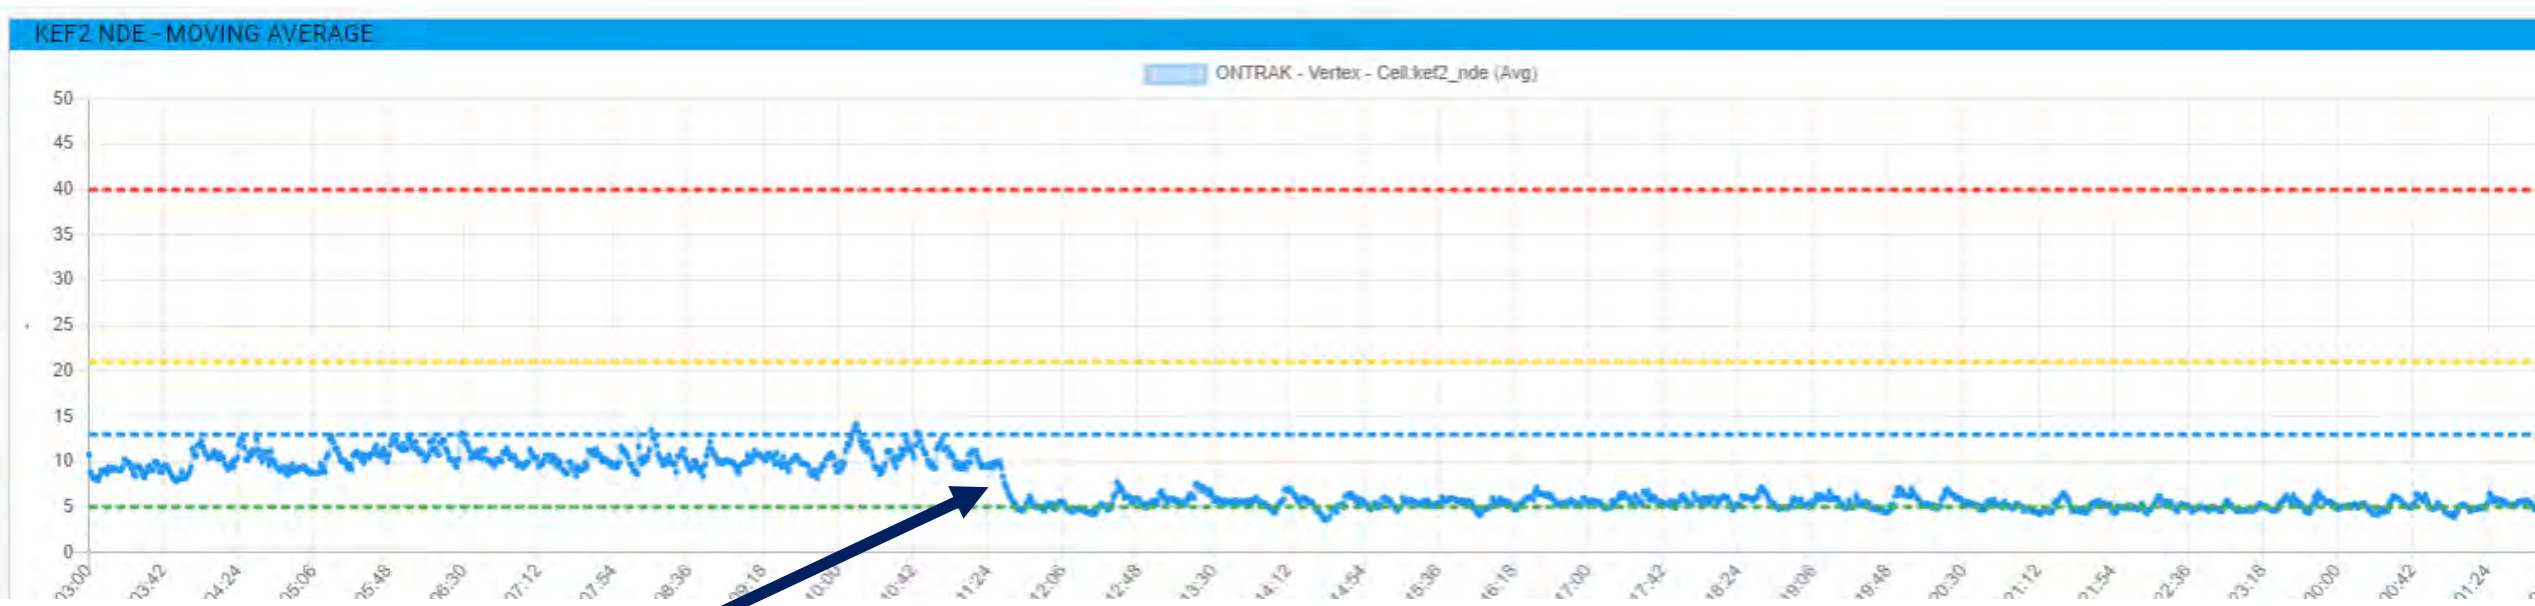
FRICITION TREND IN A UNDER LUBRICATED BEARING

NOTICEABLE DECREASE IN FRICTION AFTER LUBRICATION

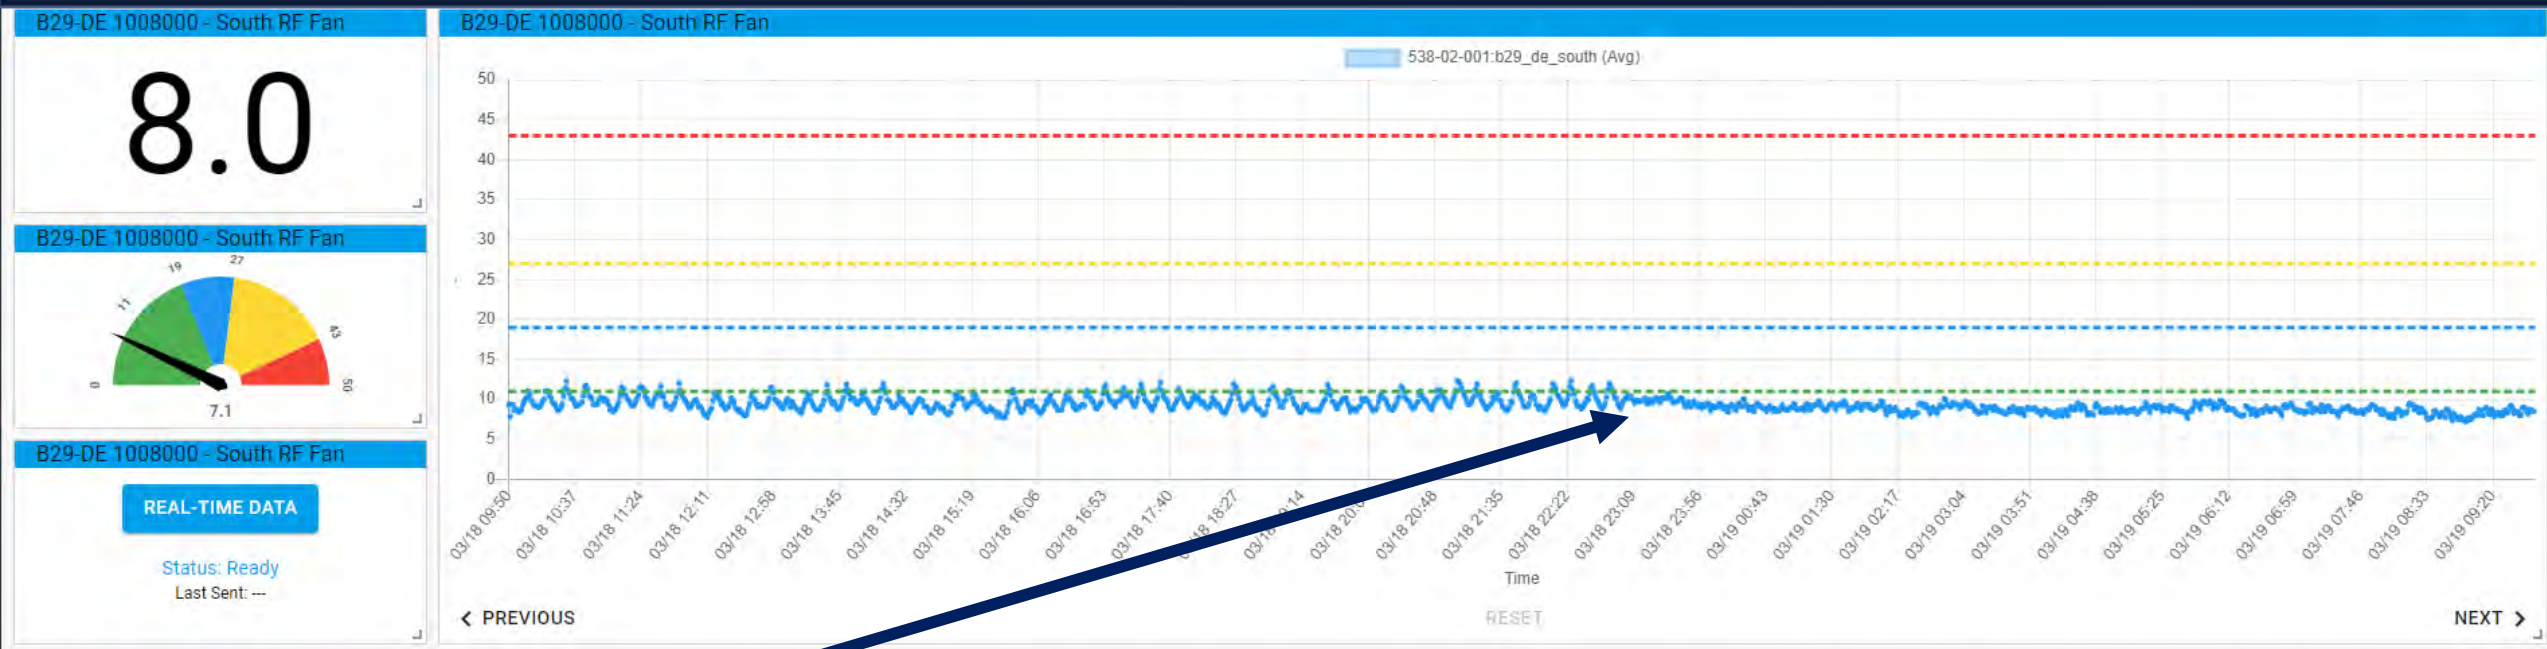
FRICITION TREND IN A UNDER LUBRICATED BEARING

NOTICEABLE DECREASE IN IMPACTING AFTER LUBRICATION

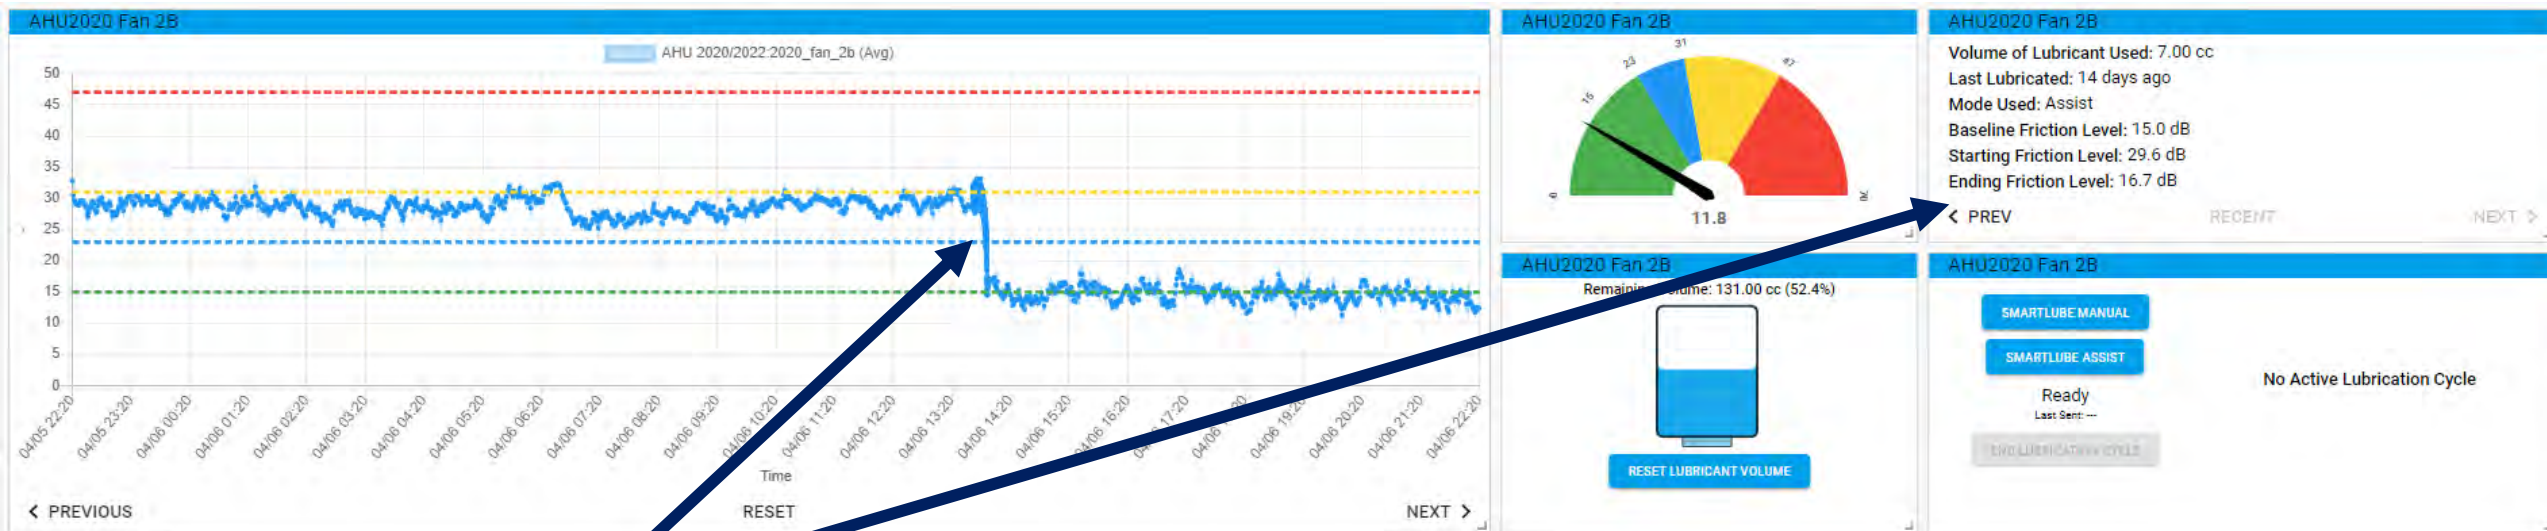
FRICTION TREND IN A UNDER LUBRICATED BEARING

NOTICEABLE DECREASE IN FRICTION AFTER LUBRICATION

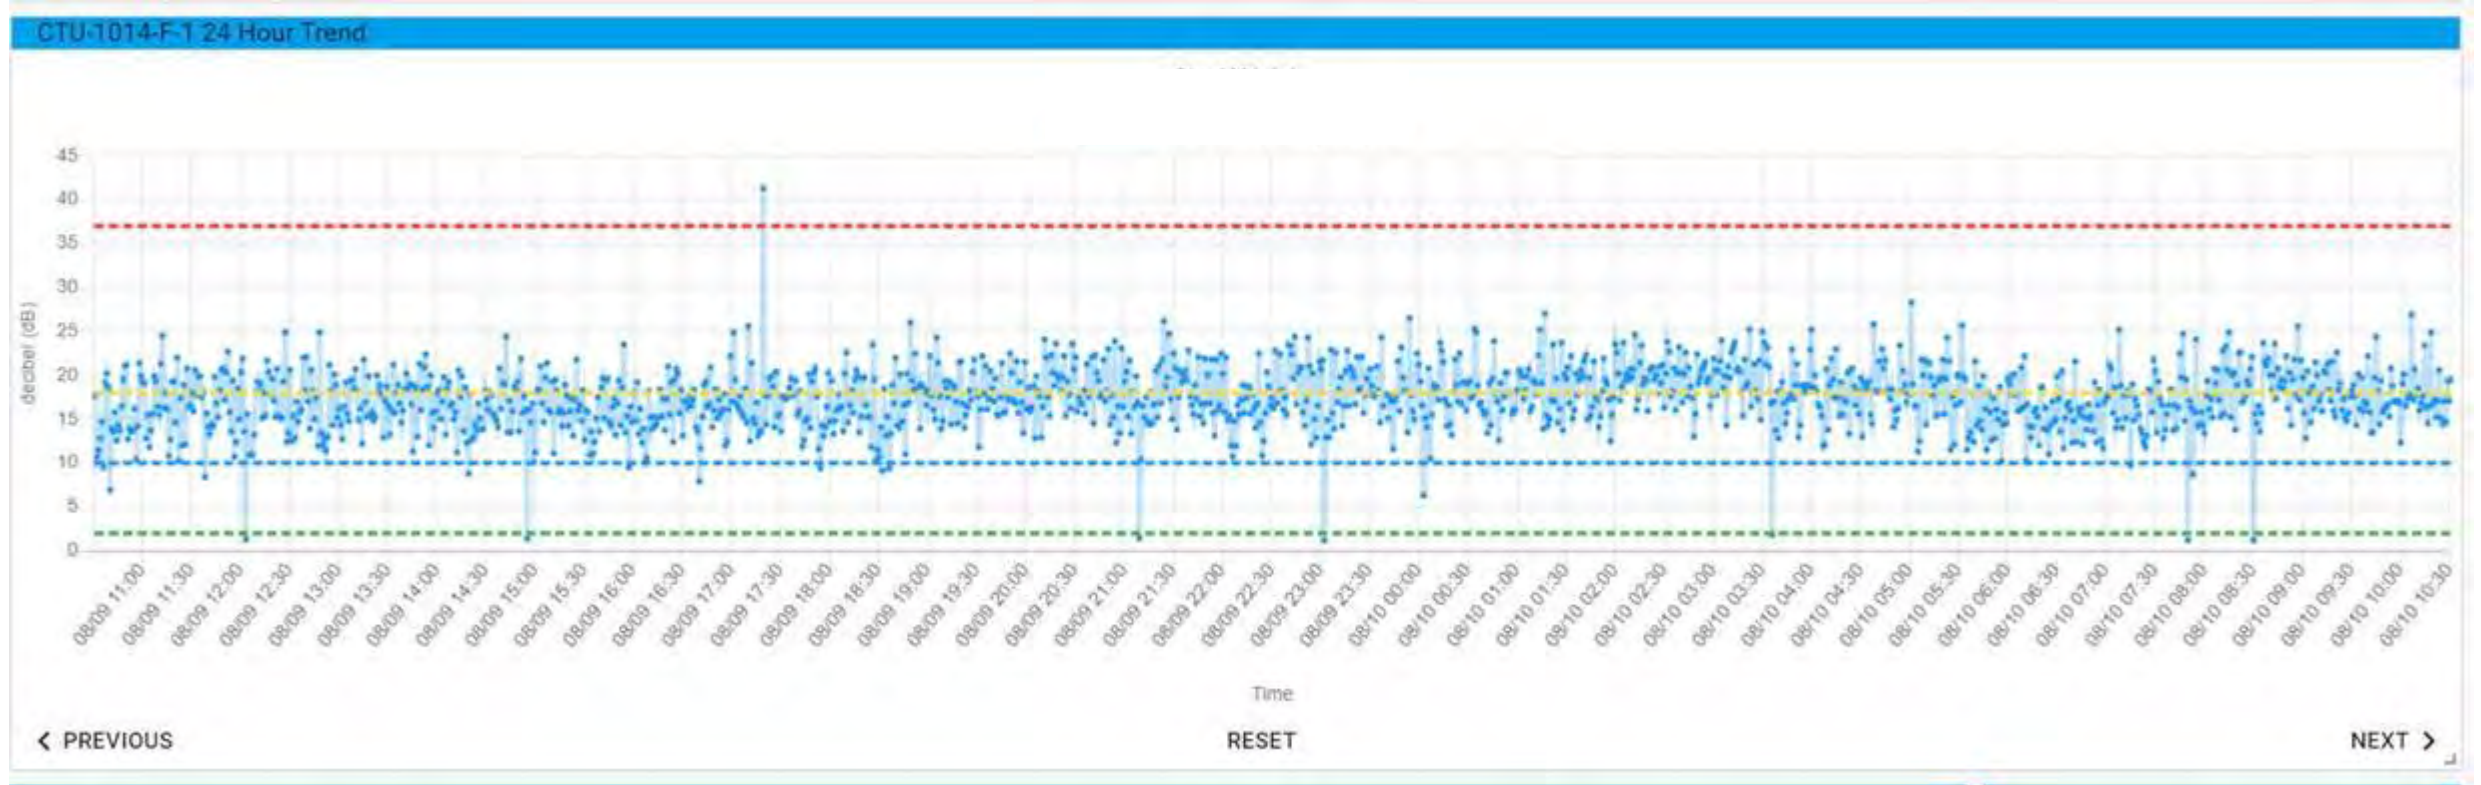
FRICION TREND IN A BAD BEARING

○ NOTICEABLE IMPACTING IN THE BEARING

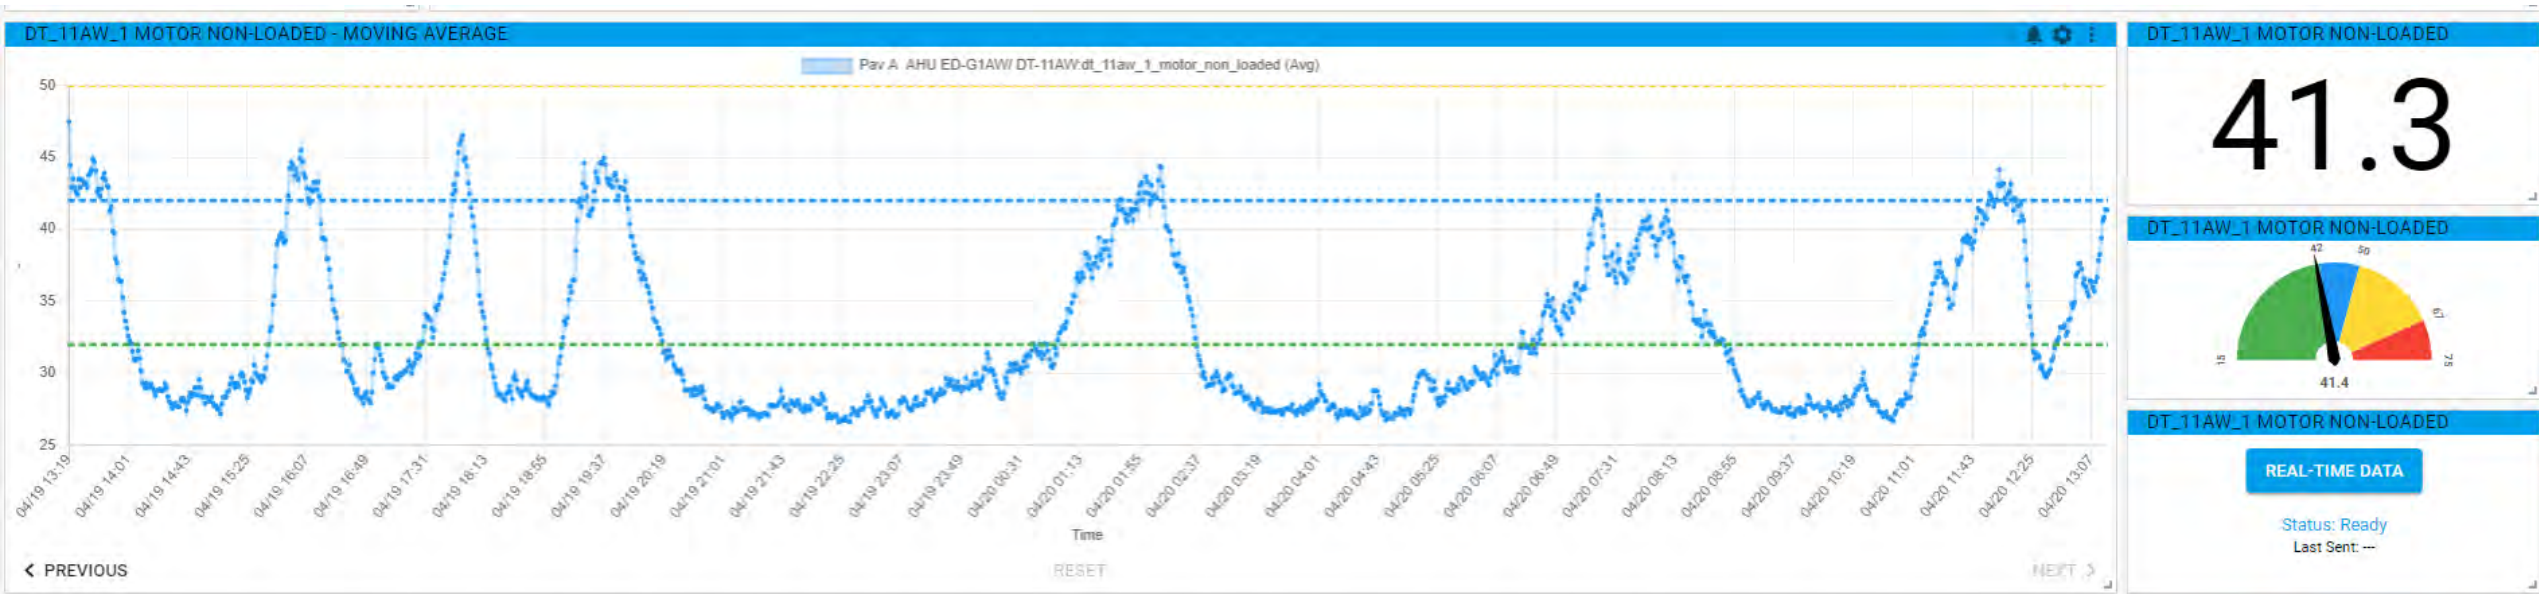
FRICION TREND IN A BAD BEARING

FRICION TRACKING WITH THE VFD. INDICATION OF ANOMALY IN THE BEARING

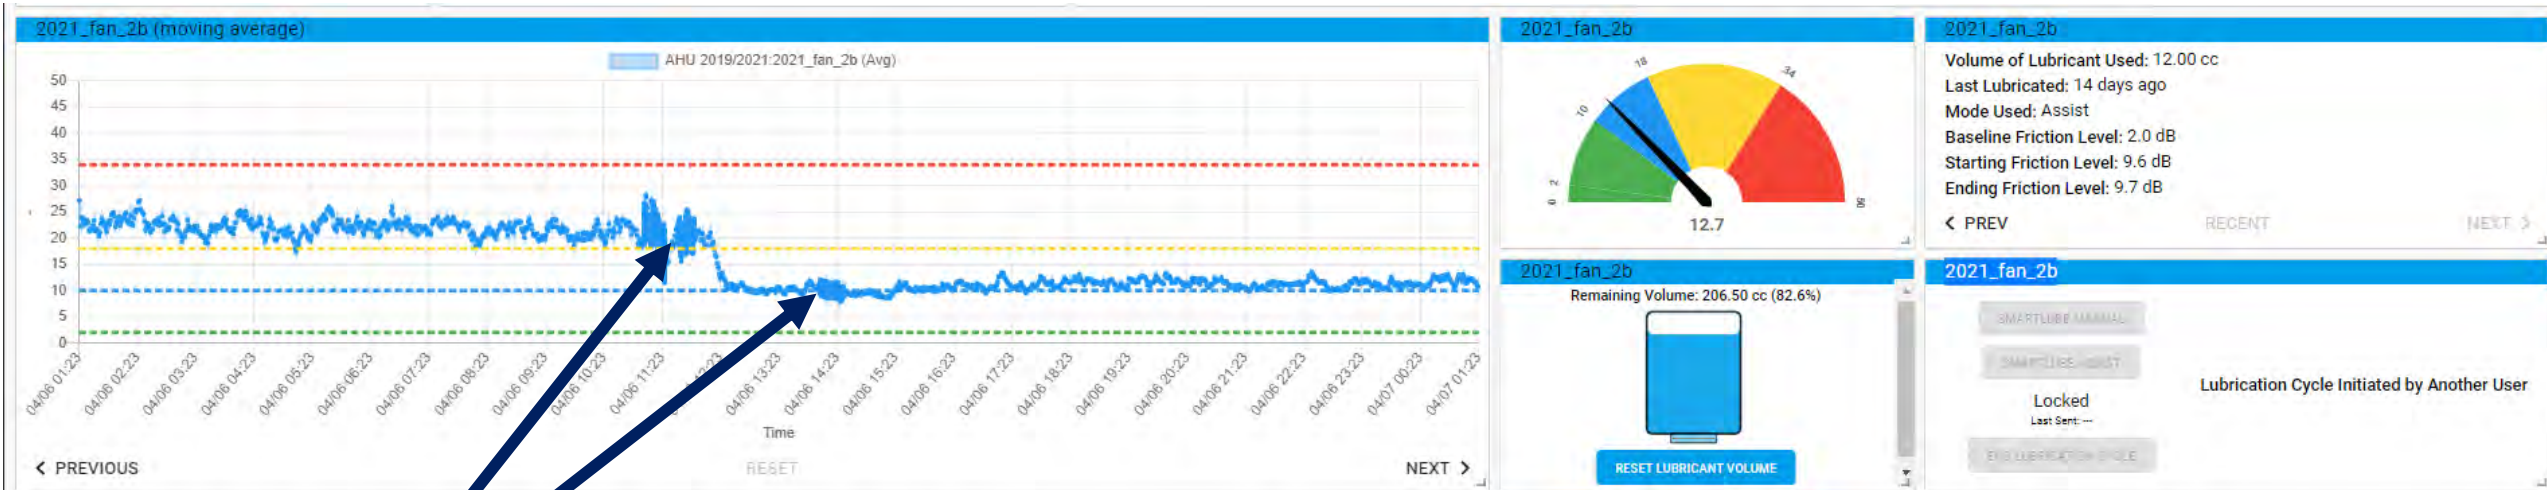
FRICITION TREND IN A BAD BEARING

WHILE THE FRICTION WAS REDUCED, IT COULD NOT BE RESTORED TO BASELINE. EITHER IMPROPER BASELINE OR DEFECT IN THE BEARING

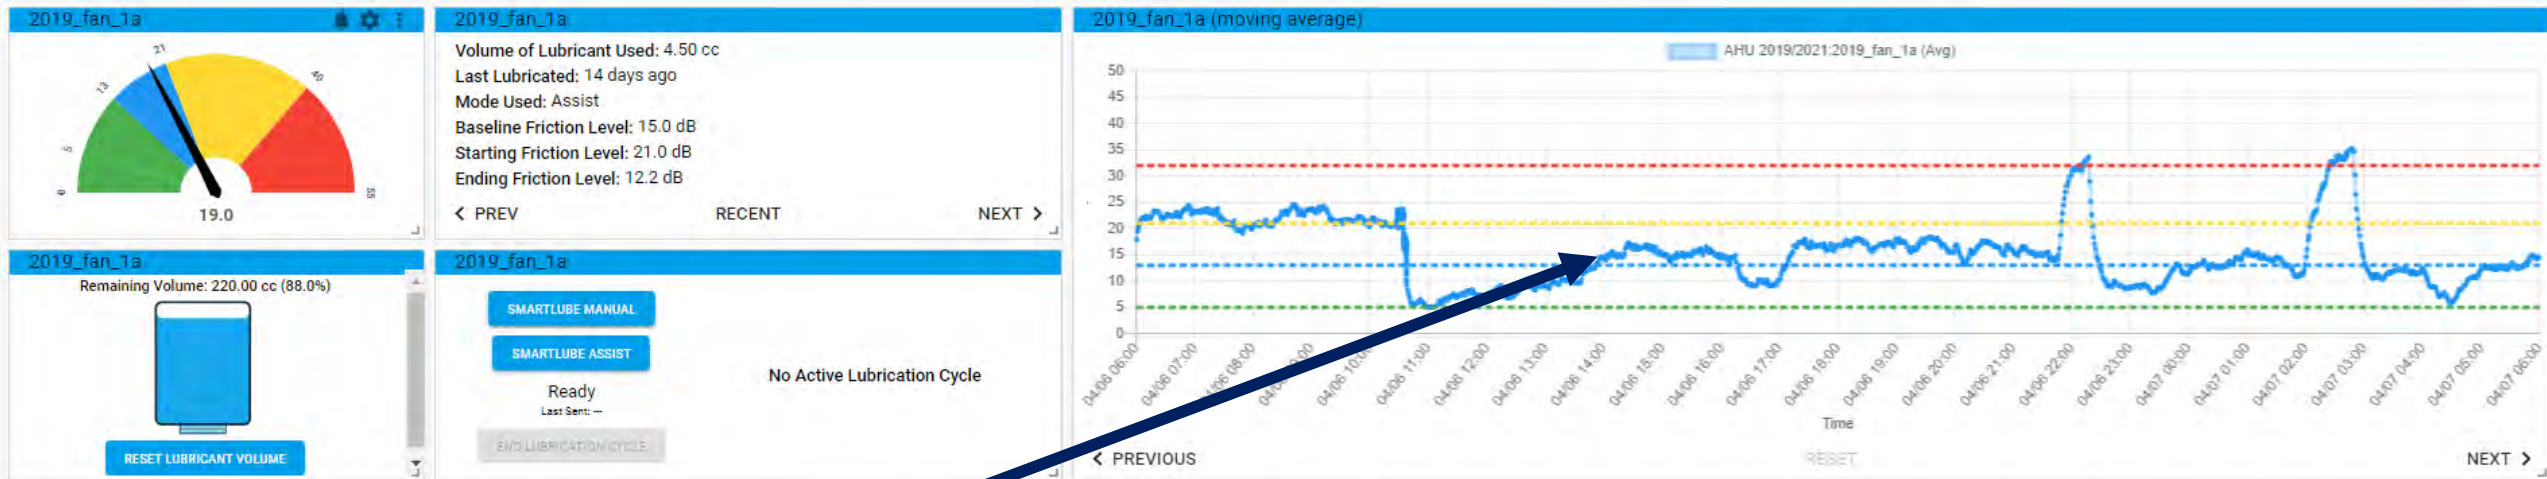
FRICITION TREND IN A BAD BEARING

WITHIN A FEW HOURS OF LUBRICATION, THE FRICTION WAS BACK UP!

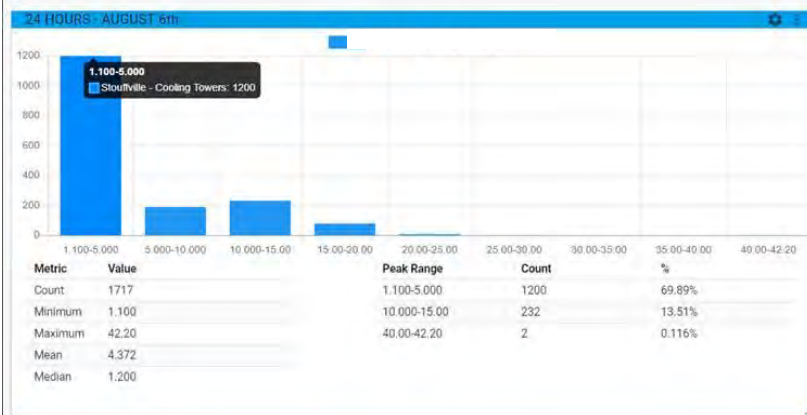
FRICITION TREND IN A BAD BEARING

NOTICEABLE INCREASE IN FRICTION OVER 4 DAYS

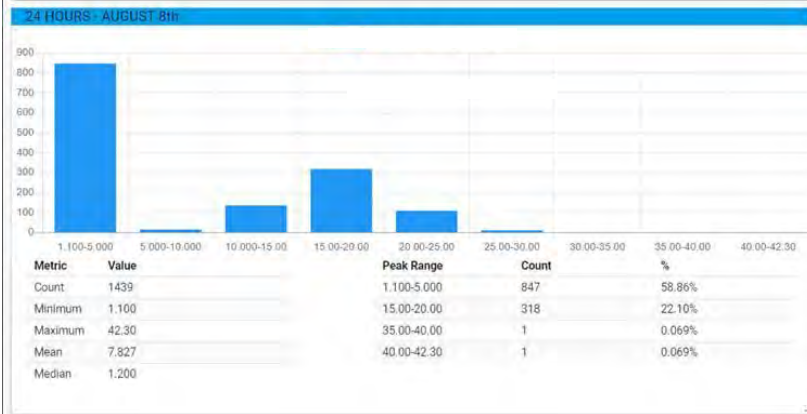
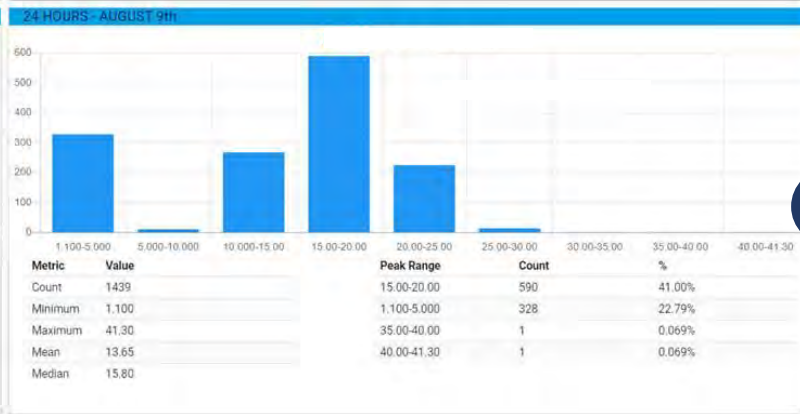
NOTICEABLE INCREASE IN THE PEAK-TO-PEAK VALUES.

NO SINGLE POINT OF FRICTION LEVEL. BEARING IS BOUNCING AROUND

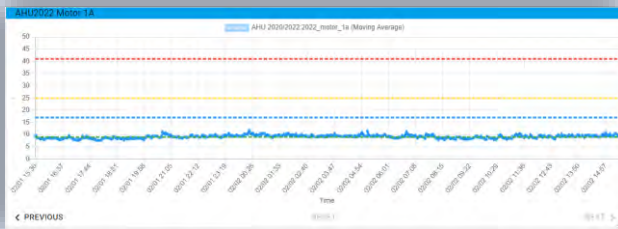
**LOOK FOR A
CONSISTENT AVERAGE
TREND VALUE**

**FRICTION IS NOT IMPACTED BY
SPEED. A HEALTHY WELL
LUBRICATED BEARING WILL HAVE A
STEADY FRICTION TREND.**

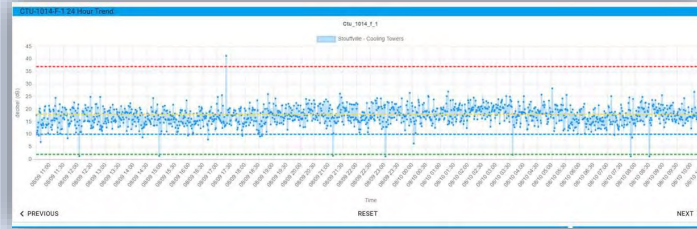
**LOOK FOR PEAKS AND
VALLEYS LESS THAN 4
DB IN AMPLITUDE**

**AN UNHEALTHY BEARING WILL
HAVE FRICTION “BOUNCING”
AROUND CAUSING LARGER PEAKS
AND VALLEYS CAUSED BY
IMPACTING**

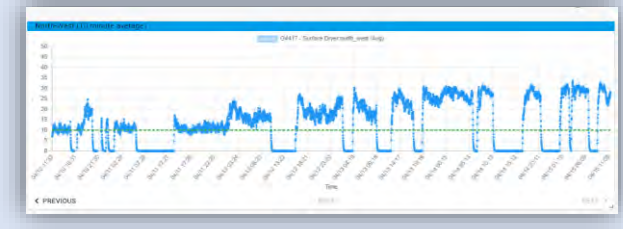
**LOOK FOR INCREASE IN
FRICTION OVER 30
DAYS**

**AN INCREASE IN FRICTION OVER
TIME INDICATES THE BEARING IS
NOT HEALTHY**

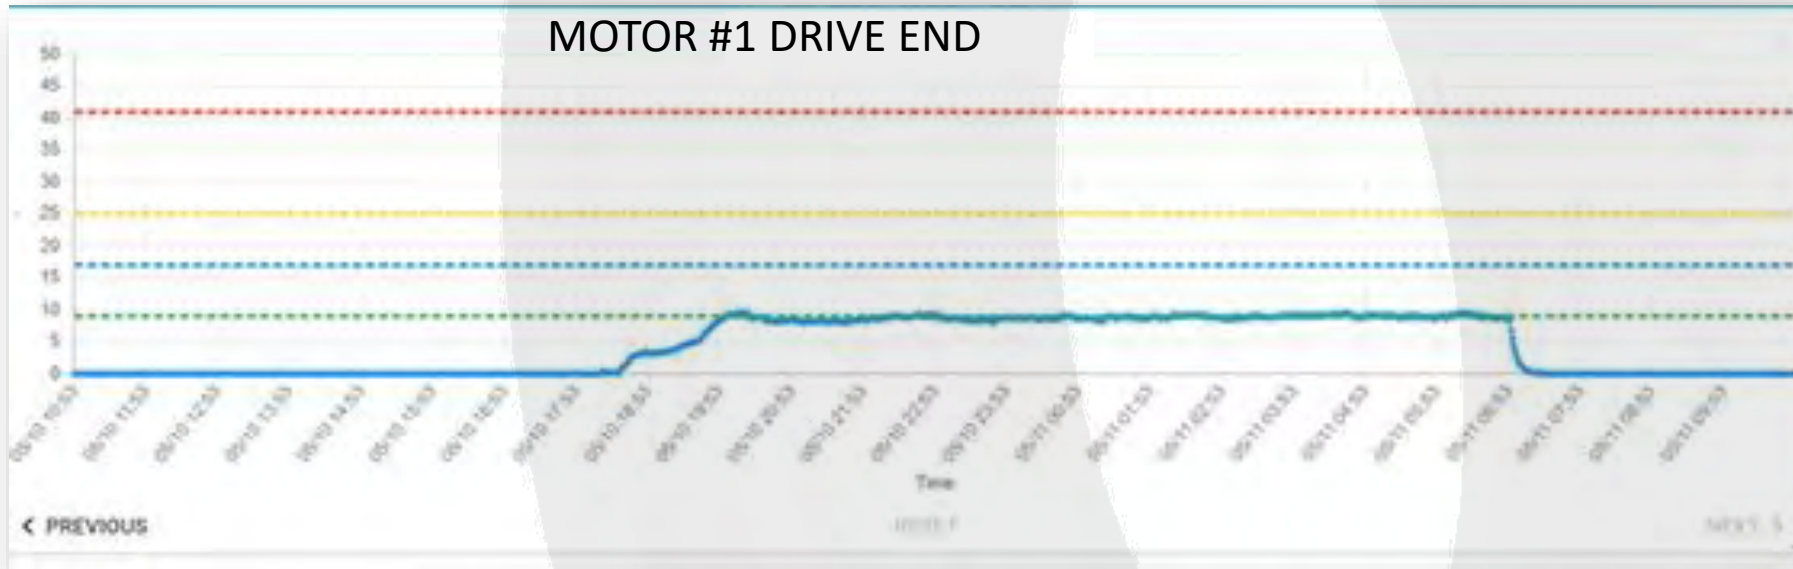
MOTOR #1 DRIVE END

IDENTICAL MOTORS WITH DIFFERENT FRICTION TRENDS

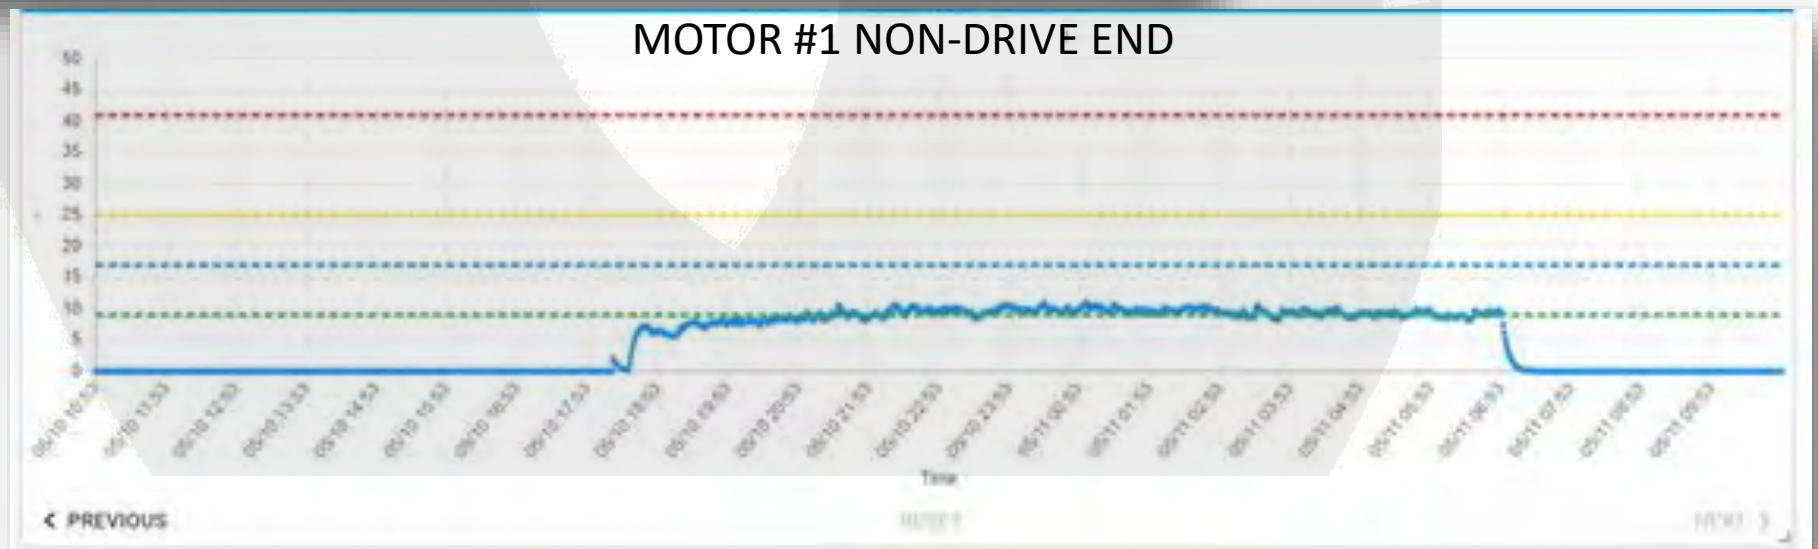
MOTOR #1 NON-DRIVE END

IDENTICAL MOTORS WITH DIFFERENT FRICTION TRENDS
