BEARING LUBRICATION *REIMAGINED*

THE ONLY REAL-TIME BEARING REMOTE FRICTION MONITORING & LUBRICATION SYSTEM. YOU WILL NEVER LOOK AT BEARING LUBRICATION THE SAME AGAIN!

ONTRAK SMARTLUBE OVERVIEW

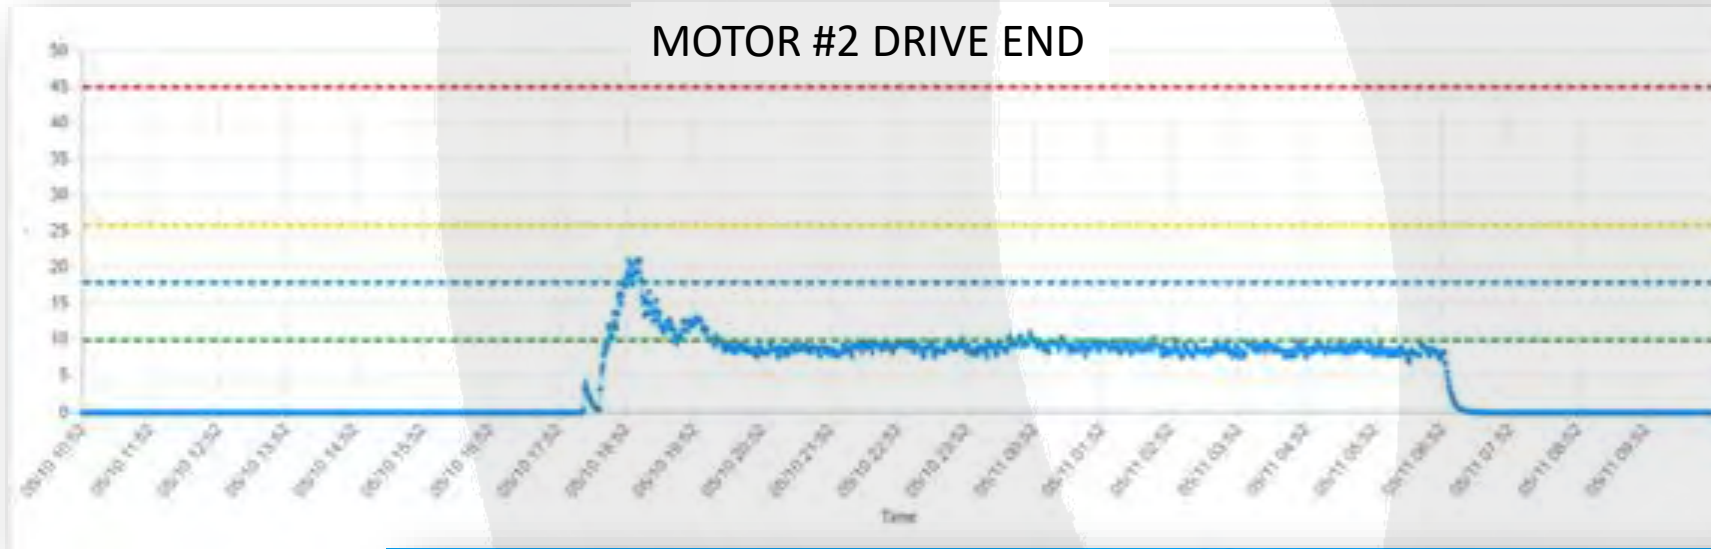
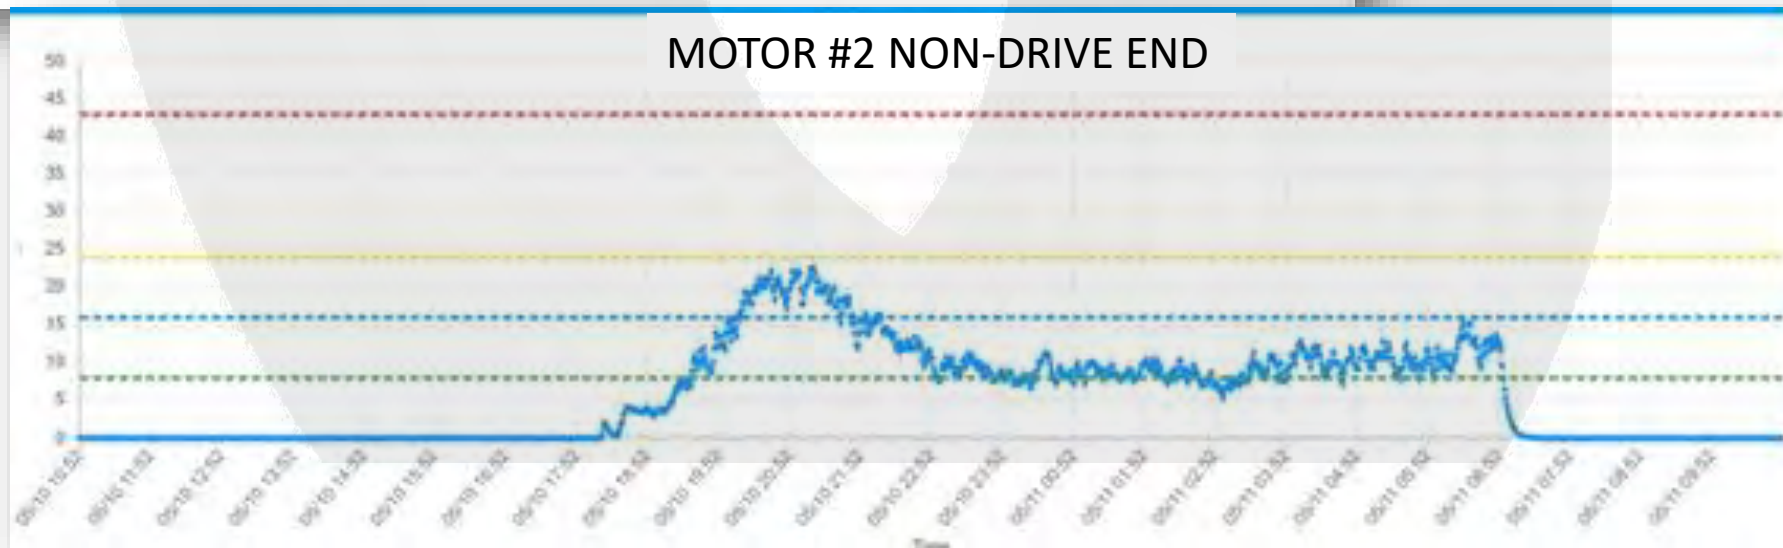
IDENTICAL MOTORS WITH DIFFERENT FRICTION TRENDS

CAUSE: THERMAL EXPANSION FROM IMBALANCE

Analysis Comment: The imbalance condition on the fan continues to be an issue. The overall amplitude in the Spectrum has increased going from 0.148 ips (inches per second) on May 2 to 0.259 ips (inches per second) on May 6. This has been reported prior and is probably the cause of looseness observed in the envelope spectrum.
